# Arboricultural impact appraisal and method statement

Edwina Mountbatten House Care Home, Broadway Road, Romsey SO51 8GH

David Cashman DipArb CUEW FArborA MICFor RCArborA

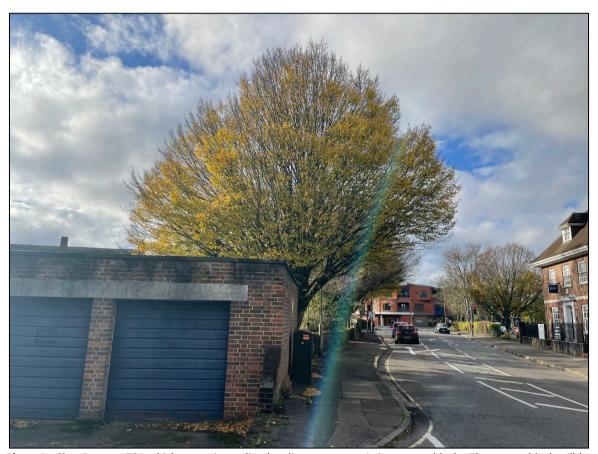
Tree T21 grows immediately adjacent to an existing garage block. It is proposed to replace the garage block with a new electricity substation. The design principle will work on the basis that the new substation foundation will be no deeper than the existing garage foundation to reduce any impact on roots growing beneath the garage. This installation can be carried out without any significant new excavation into existing soil levels, which should allow any roots below the existing building to be left intact. In summary, if the guidance set out in SGN 9 *Installing/upgrading surfacing in RPAs* and SGN 10 *Installing structures in RPAs*, is observed, we believe that the proposed works can be implemented without any long term detrimental impact on tree health, and therefore local character.

**Photo 1:** Showing tree T21 which grows immediately adjacent to an existing garage block. The garage block will be replaced with a new electricity substation, the design principle is to ensure the new foundation is no deeper than the existing garage foundation so that roots beneath the garage are not affected. The demolition of the garage will be carried out under arboricultural supervision.

Operation of site cranes and piling rigs: Provision will be made to prevent site cranes and piling rigs damaging trees, as described in SGN 5.	All retained trees	SGN 5 Site cranes & piling rigs
Regular arboricultural supervision: Provision will be made to carry out and record agreed arboricultural supervision, as described in SGN 1.	All retained trees	SGN 1 Monitoring tree protection
<b>Removing surfacing and structures in RPAs:</b> These operations will be carried out as described in SGN 8.	T8, T9, T11, T12, T13, T14, T16, G17, T21	SGN 8 Removing surfacing and structures in RPAs
Installing/upgrading surfacing in RPAs: These operations will be carried out as described in the SGN 9.	T8, T9, T11, T12, T13, T14, T16, G17	SGN 9 Installing/upgrading surfacing in RPAs
Installing structures in RPAs: These operations will be carried out as described in SGN 10.	T21	SGN 10 Installing structures in RPAs
